Arborist Report

March 2009

Karen Christman, Certified Arborist (Certified Arborist #WE3807A)
ARBOR SERVICES *Hands On Tree Experts*
P.O. Box 3585, Santa Barbara, CA 93130 805-687-7779

RE: The Oak Cottage of Santa Barbara
1820, 1822, 1826 De La Vina Street
Santa Barbara, CA

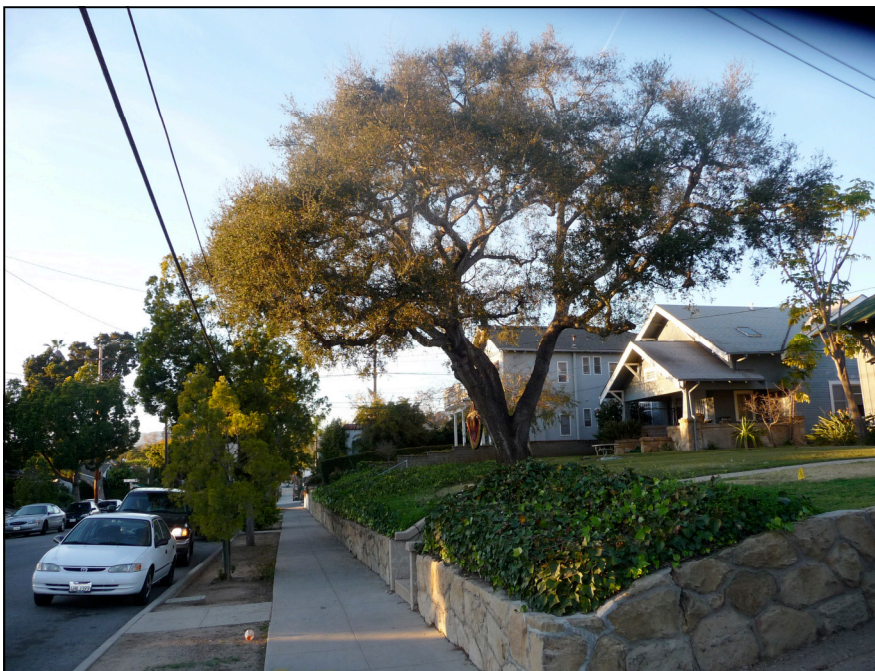
Figure 2: Southern view of *Quercus agrifolia* in front yard setback of 1826 De La Vina Street, Santa Barbara. Two *Podocarpus* street trees are in the west understory. (Christman, 2009)

The subject Oak has three main trunks at approximately five feet above ground level (AGL). The DBH is approximately 46 inches. There is no trunk flare on the west side of the main trunk. Aged frass of a coarse consistency was detected in the crotch of the tree indicative of the Sycamore borer (*Synanthedon culciformis*), a non-threatening pest. The tree also has an Oak Moth (*Pyryganidia californica*) infestation. Throughout the trunks and on the ground are aged pupae casings from the pest.

The inner canopy has moderate **epicormic** growth and little to no internal branching as if **lion tailed** in previous pruning events. Foliage is sparse and concentrated on the branch ends, but new growth was emerging at the time of the VTA.

Based on the VTA, the *Quercus agrifolia* is in fair condition. The stripped out interior branching (possibly done to increase light penetration for the lawn area) has stimulated epicormic growth. Overthinning or lion tailing is a practice to be avoided due to its adverse effects on the tree (Lily, 2001). The excessive removal of the inner lateral branches has displaced branch weight to the ends. It also makes it strategically difficult to reduce crown size in the future since there are no laterals to cut back to. The canopy will ultimately need to be trimmed off the adjacent Podocarpus street trees and utility lines.

The Oak Moth infestation has also contributed to the subject tree's sparse canopy. Oak Moth larvae feed on the foliage and commonly defoliate Oaks in our area. There can be up to four cycles per year. A healthy tree can sustain defoliation. Stressed trees, however, are often treated to prevent further decline.

1. Deep root aerate and fertilize Oak rootzone prior to construction to improve soil conditions and support healthy generation of new foliage and roots.

2. Mulch CRZ with 4 to 5 inches of wood chips (keep off tree base) to improve soil conditions and minimize future soil compaction.
3. Install temporary chain link fence (six feet tall) at edge or beyond the dripline prior to project commencement.

4. Incorporate hardscape design and materials that minimize rootzone compaction, disturbance, and promote gas-exchange and water percolation.
5. Exclude plantings within Oak dripline for a minimum of two years.

6. Contract with Consulting Arborist for biweekly inspections of tree during and after project commencement to provide guidance on tree health issues such as Oak Moth and rootzone conditions.

7. All future pruning shall be under the standards set forth by the ISA and supervised by a Certified Arborist. The object shall be to preserve as much foliage as possible.

8. Restrict all trenching within the CRZ of the subject Oak unless supervised by a Certified Arborist. Exposed soil profiles within CRZ shall be covered with moist burlap to prevent rootzone desiccation.

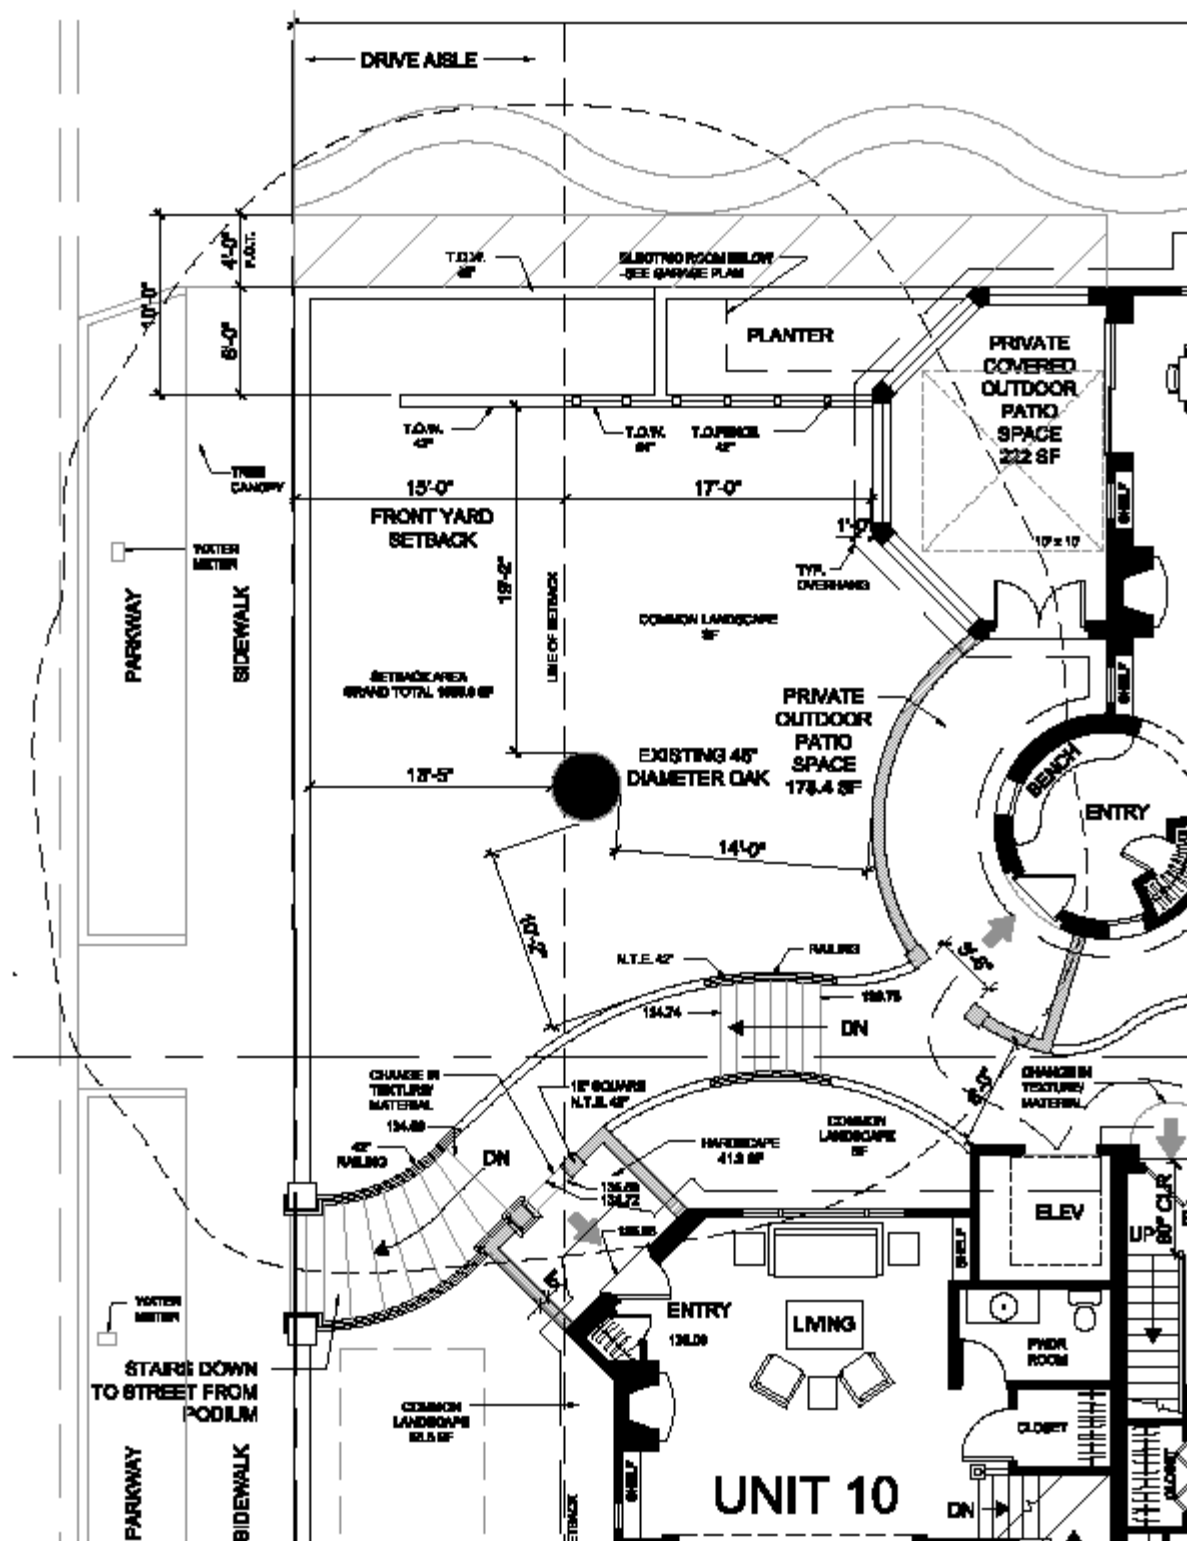
APPENDIX III: Development Proposed within *Quercus agrifolia* CRZ

The construction of a driveway at street level approximately 20 feet north of the main trunk will have significant impact on the CRZ (Appendix I). Up to 30% of the CRZ will be eliminated through excavation and further loss could be incurred through desiccation if the soil profile is left exposed during construction for an extended period of time.

The outdoor patio area off of unit #14 approximately 14 feet to the east and walkway approximately 10 feet to the south of the subject Oak will be less severe (15% to 25% root loss in CRZ), especially if hardscape design such as bridging and materials such as permeable pavers are utilized to minimize root damage and soil compaction. Large roots are essential for tree stability and storage. In construction, they are typically damaged from excavation and trenching. Fine roots are required for water and nutrient uptake. These finer roots are easily damaged from soil compaction inflicted from grading or heavy foot traffic. Root loss symptoms include, but are not limited to, foliar and branch dieback, instability, reduced vigor, greater susceptibility to disease and pests, and epicormic growth.

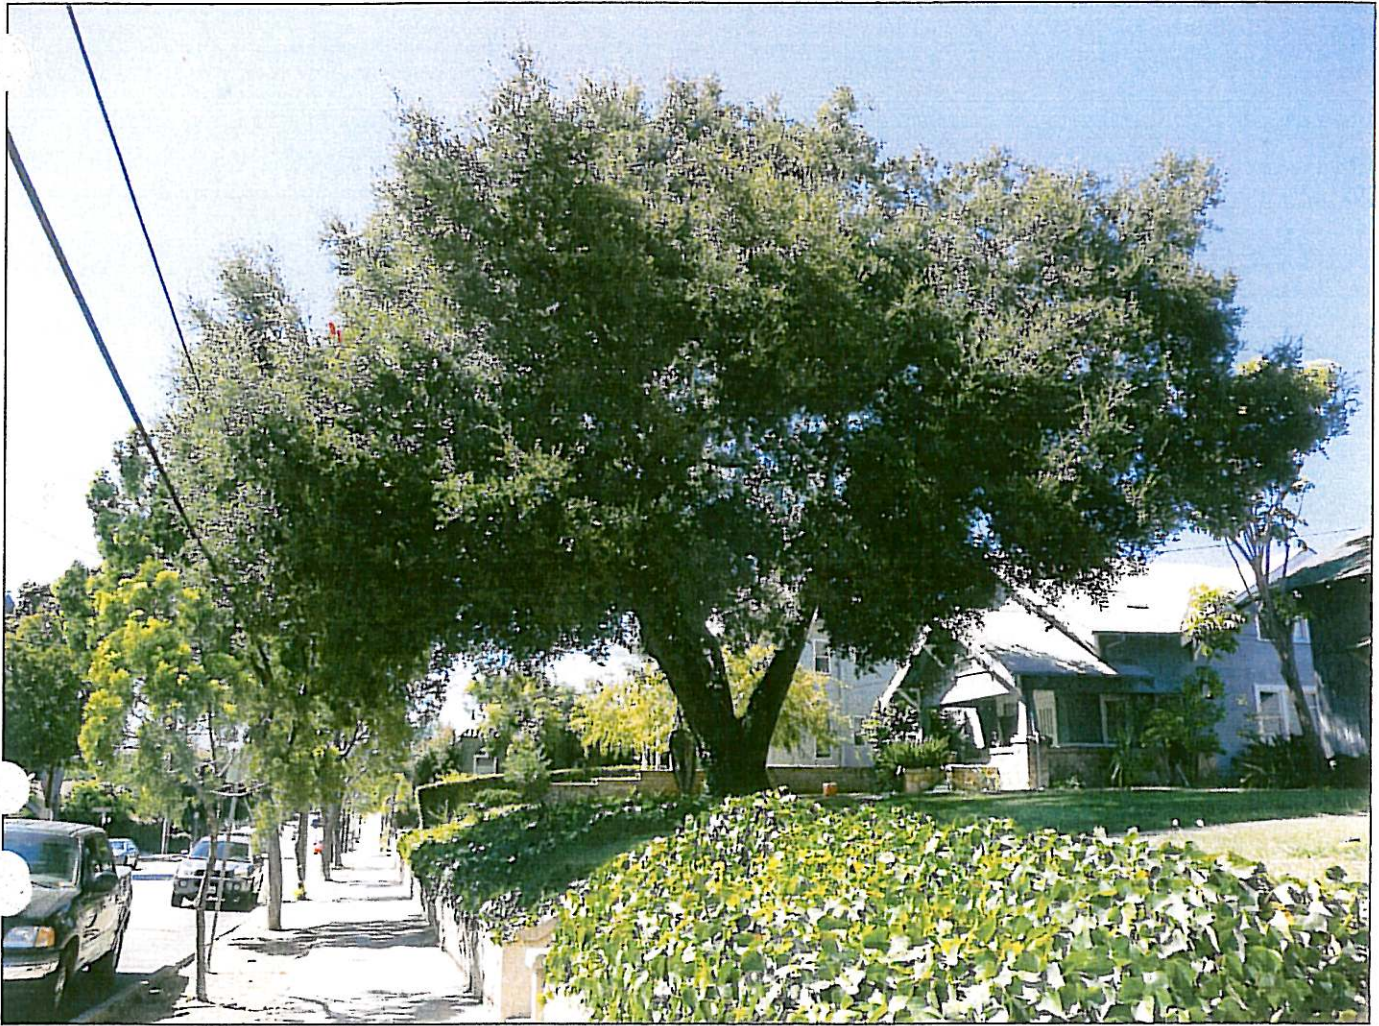
The subject Oak is in fair condition (Figure 1). Foliage density, especially epicormic growth has increased approximately 15% since my 2009 VTA. Oak Moth damage is minimal and appears to be at a low point in the cycle. Cultural conditions and understory landscape remains unchanged. Soil conditions also remained visibly unchanged.

Oak Cottage of Santa Barbara development includes the construction of a staircase and walkway within the southwest portion of the subject tree's dripline, approximately 17 feet from the main trunk. Approximately 10% to 15% of the CRZ will be adversely affected by the excavation, grading and compaction required for this installation. A stone patio within the northeast CRZ will require minimal grading and compaction. Plants compatible to Oak understory have been called out for the landscaping under the tree with the bare soil areas to be mulched with wood chips. A fence to the far northeast of the dripline will require only post-hole digging and affects less than 5% of the CRZ.

The development of the The Oak Cottage of Santa Barbara will have less root zone intrusion and adverse impact on subject Oak than the Multi-unit development proposed in the 2009 Arborist Report. The construction of the staircase will have the greatest intrusion due to root loss from grade lowering. The walkway, fence, stone patio, and landscape installation will have minimal to moderate impact depending on the materials used and installation protocol followed within the work area. Although the tree's overall condition has slightly improved in the past year, protection measures must be adhered to before, during and after site development.

Figure 1: 1820 - 1826 De La Vina Street *Quercus agrifolia* southwest view. (Christman, 2010)

In addition to the following recommendations, the preparation of a Tree Protection Plan (TPP) by a Certified Arborist prior to job commencement is highly advisable. A TPP offers specific guidelines and serves as a communication tool in the construction process.

- 1) Deep root aerate and fertilize Oak rootzone prior to construction to improve soil conditions and promote healthy generation of new foliage and roots. (Winter 2010) *This will be second application, first in 2009*
- 2) Mulch dripline with 4 to 5 inches of wood chips (keep off tree base) to improve soil conditions and minimize future soil compaction.
- 3) Install temporary chain link fence (six feet tall) at edge or beyond dripline prior to project commencement.
- 4) Designate tree dripline as a "no dump, wash or staging area" during construction.
- 5) Incorporate hardscape materials and design that minimize root compaction and promote water percolation and gas exchange.
- 6) Install Oak compatible plantings within the Oak dripline. Keep number minimal and use smaller pot sizes.
- 7) Contract with a Certified Arborist to inspect tree before, during and after development.
